Investigating water pipelines using IR-free potential measurements under stray current interference conditions

Keywords: IR Free Potential Measurements, Stray Current Interference, Protection of water pipelines, Integrated CIPS/DCVG

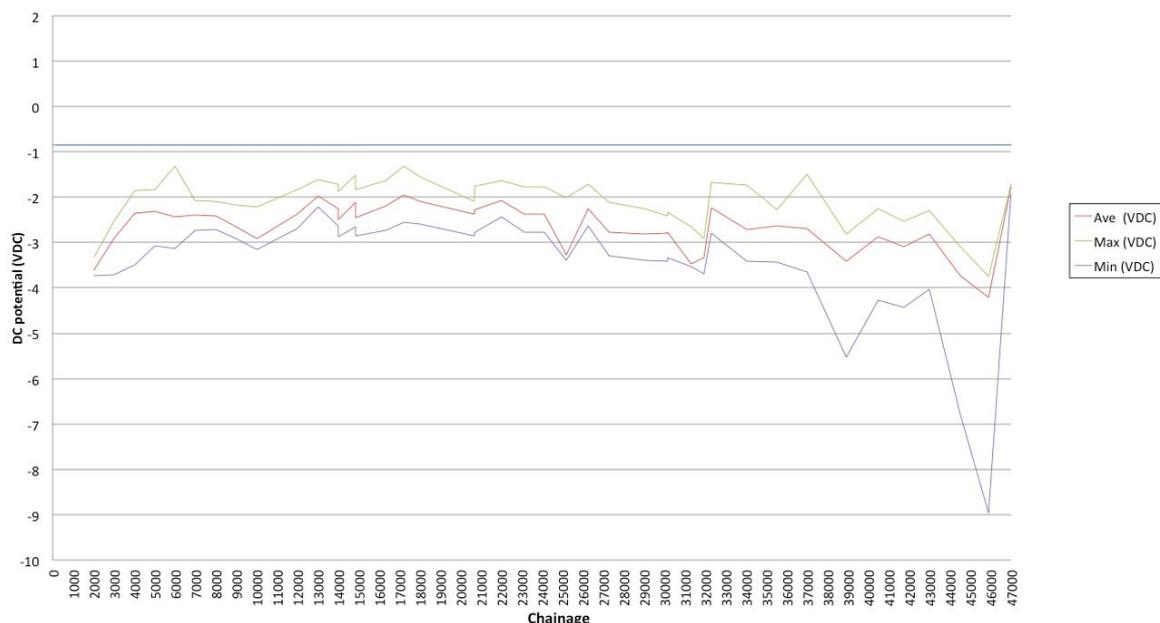
Potential recordings were taken using data loggers with 10 MΩ input impedance sampling at 30s intervals and portable reference electrodes at surface. The maximum, minimum and average potential from each data logger has been extracted and plotted against chainage. (Fig 1) The results indicate that the pipeline is fully protected in terms of the

-0.95V Cu/CuSO₄ "ON" criterion over a period of 24 hours, as per SANS 10121.

The effect of stray current interference as the pipeline approaches the railway line can clearly be seen in the increasing negative potentials after approximately Ch 32 km

Fig 1: Average, Minimum & Maximum Potentials over 24 hours

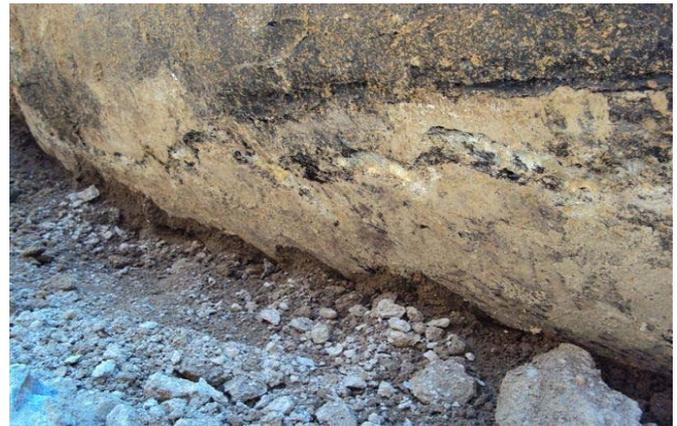
| Ref. | Location | IR-Free Potential (VCSE) | Excavation/ Comment |
|---|---|---|---|
| D2 | ~Ch 5 550, | -0.94 | Bend, cracks in coating. PCM D27 |

The photograph below shows the excavation and bitumen damage on the bend at Ch 5560m
